## Dutch Barn Preservation Society

### Barn Tour, Knox, Albany County, 22 October 2011

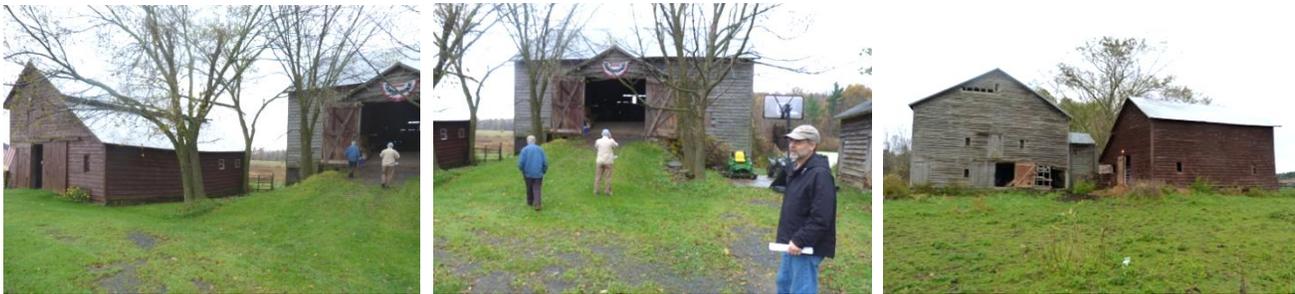
There are two barns on the south side of the road just east of the farmhouse, shown in the left and center pictures. The one in the center, with the ramp, is the Dutch Barn; the third view shows both from the east, with the Dutch Barn on the left.

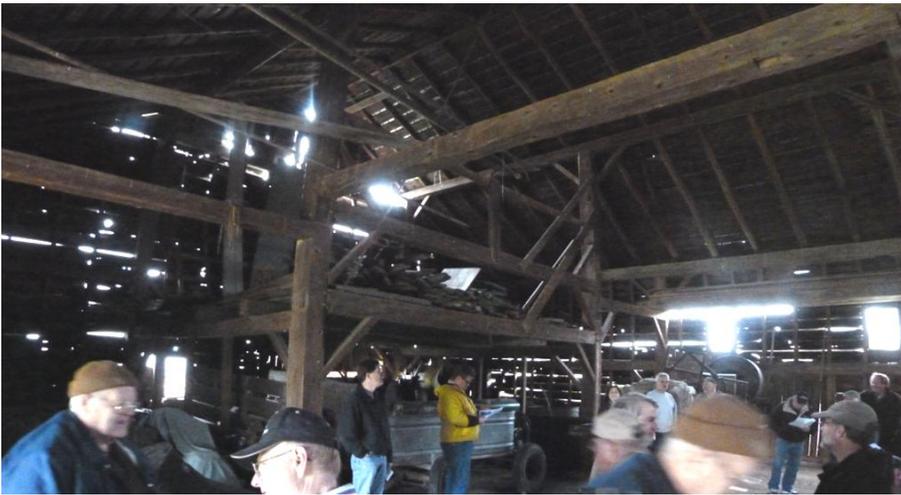
This is a three bay Dutch barn with a ramp to the second level on the north side. Here are two interior shots-first, as we all stand on the center section, after coming in on the ramp; At the second level, the westerly bay is a large open space extending from ground level up to the roof. Clearly, this large volume was designed for hay storage.

On many of the later Dutch Barns a ramp was added to make it easier to get the hay into the barn- and I note that hay storage is much more important in later barns, because after 1800 the farms placed more emphasis on dairy, and cows need lots of hay. There is also a hay track up in the peak of the gable, and some of the ropes and pulleys used to move it around the barn and drop the hay.

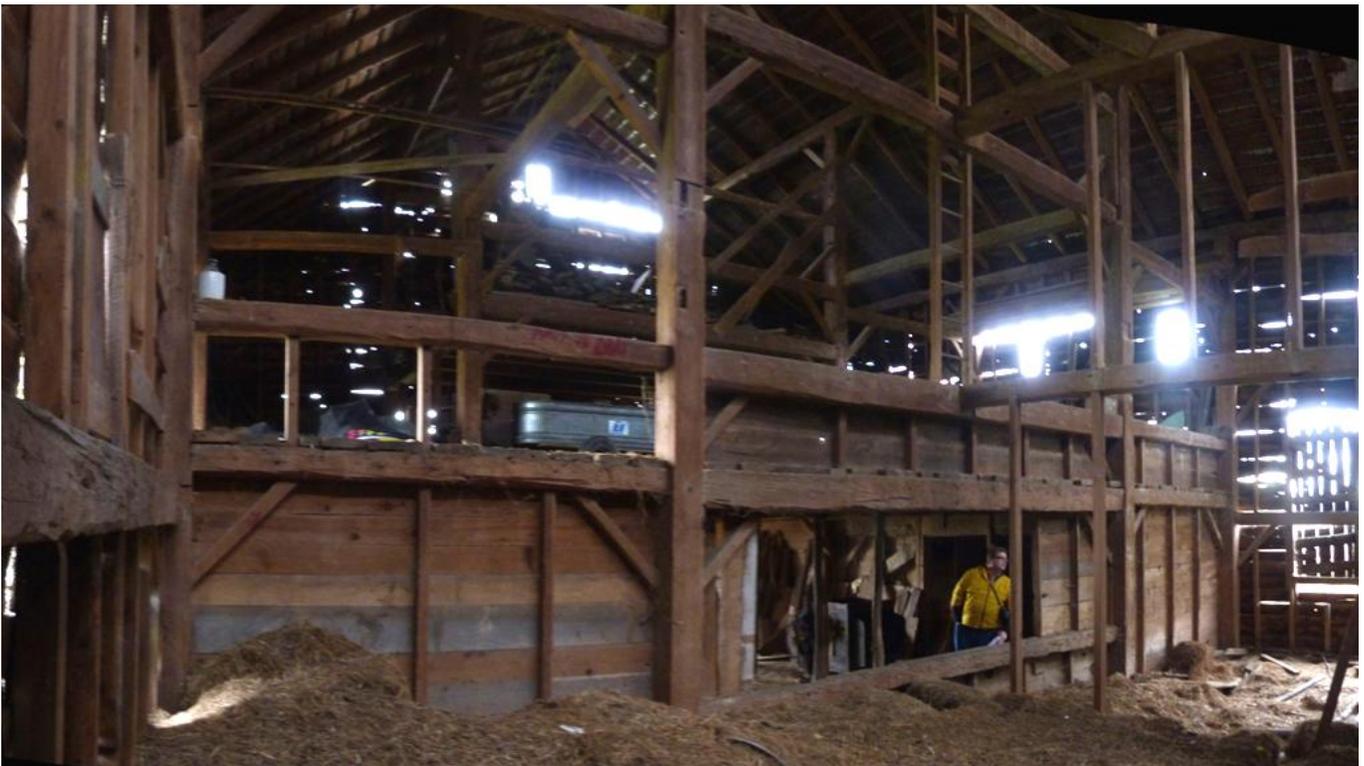
The second view, below, is from the first level in the NW corner, showing this large open bay. The side of the ramp is clearly visible, with first floor walls, and an open center section where you can see one of our group looking out.

A question here is whether the ramp was original or a later addition. Arguments can be made both ways. There is a sign over the ramp which says 1873. Although the frame is clearly a Dutch barn, the ramp is perhaps more English. The frame is a timber frame, but all the smaller studs and uprights around the

perimeter of the barn are sawn, and most seem circular sawn, as noted by Bill McMillen. This likely places the barn after 1840, and a date of 1850-1873 is a good guess. The 1873 date could refer to the ramp, or to the barn itself; both are plausible, though a date of 1873 for the barn would make it one of the newest of the historic Dutch Barns.

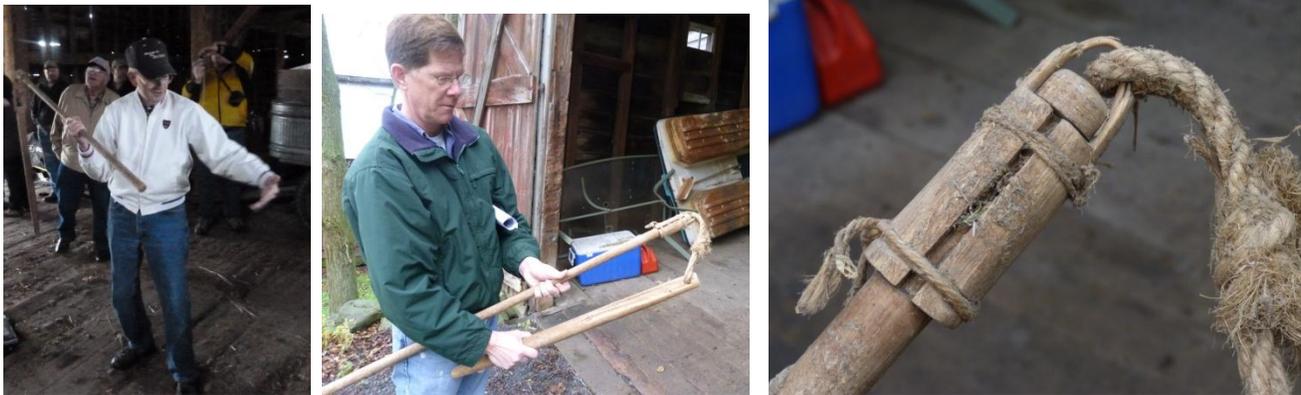
As Al was talking about the threshing floor and the use of flails, Ken Saddle mire brought out an old flail he had found in the barn. Here is a picture of Al demonstrating its use, and another of Bruce Nelson with the flail. The connection at the end allows it to spin around.

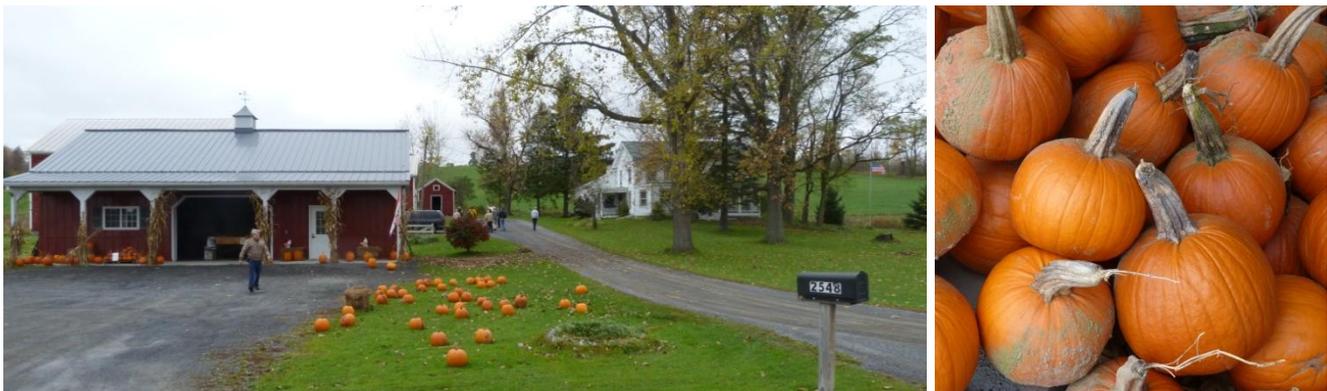
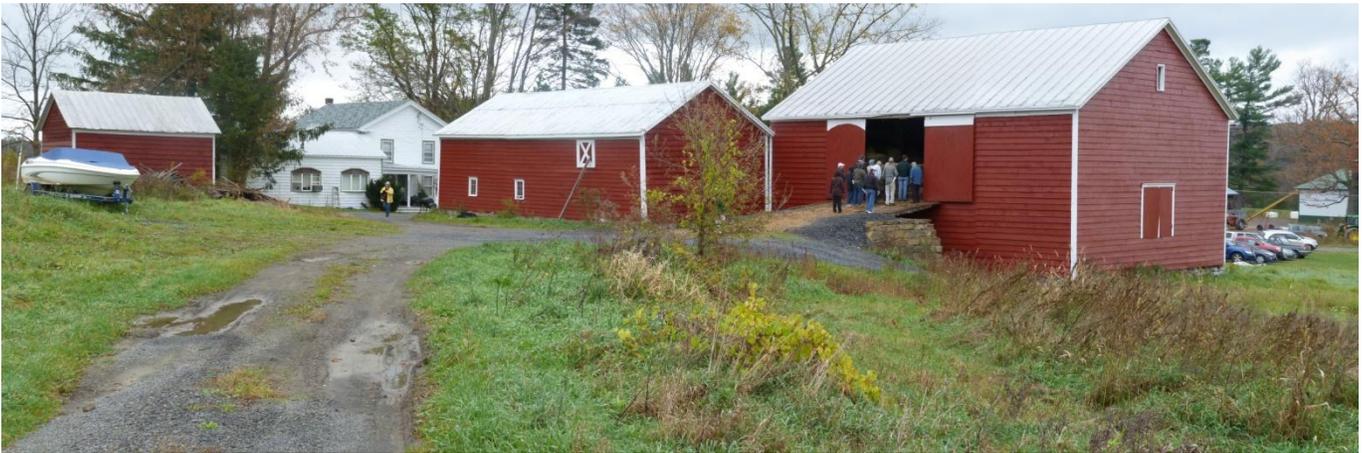
This barn was built partly into the side of the hill, suggesting it and the ramp may have been built at the same time. It is also a three bay barn, and the Upper level seemed remarkably similar to the first barn we saw. However, here all the smaller members and the uprights are sawn, but with an up and down saw, suggesting this is earlier than the Saddlemire barn.

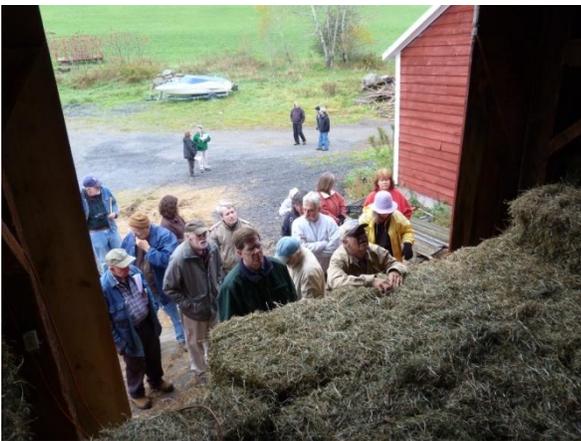
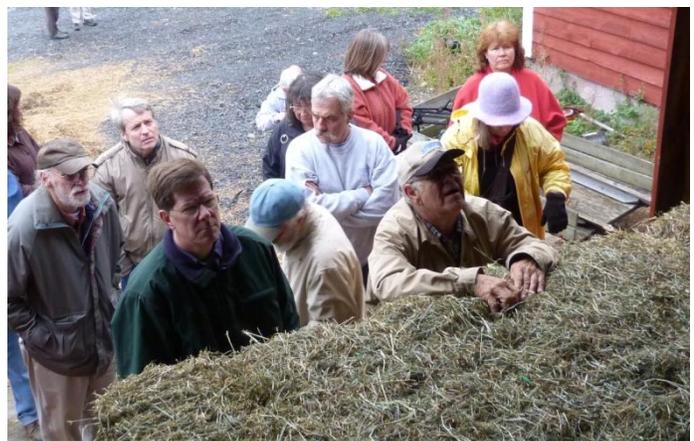
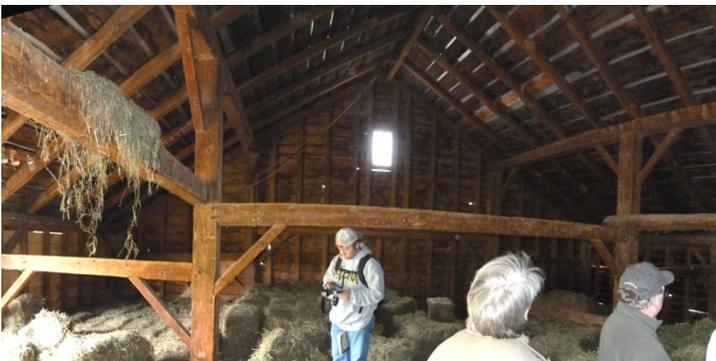
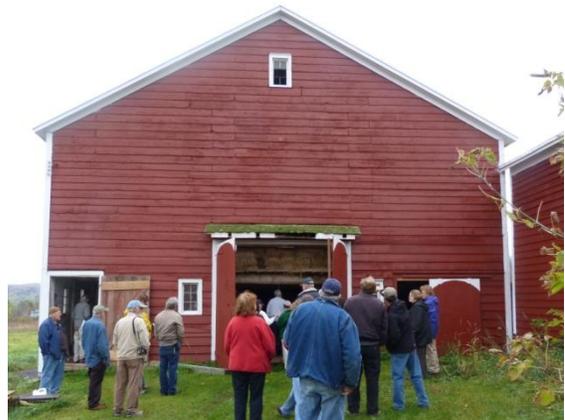
The upstairs was pretty full of hay, so it required a bit of climbing up and over the bales to get inside.

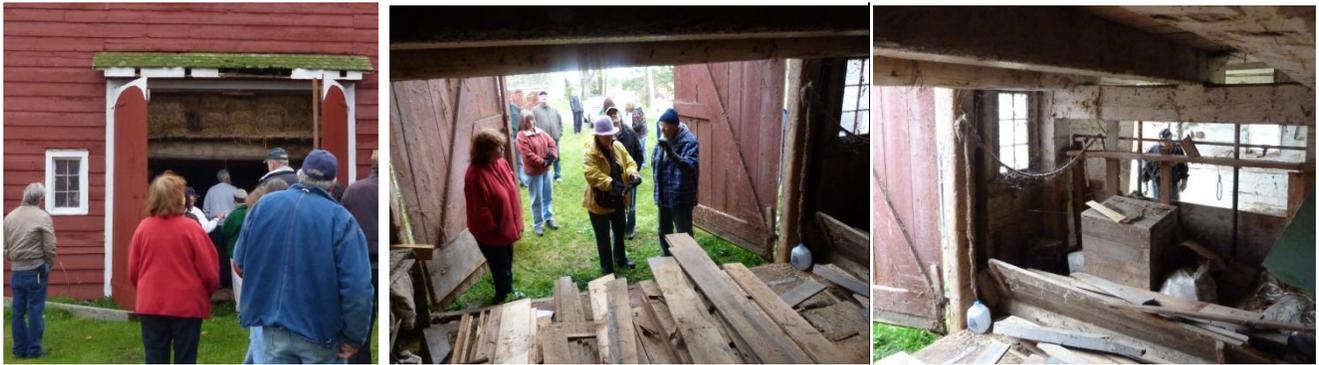
Downstairs the structure was curious- it looked as if the entire ground floor had been rebuilt and strengthened. Notice in the front view looking through the barn doors that the floor of the upper level is about 2/3 of the way up the doorway.

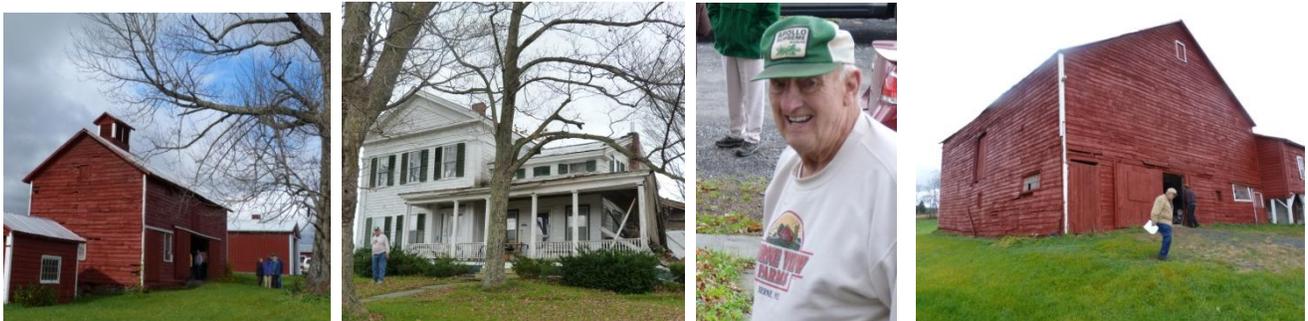
The Barn is another late, tall, three bay Dutch Barn with a ramp on the road [uphill side.] My pictures inside didn't turn out that well; I was more fascinated by Gerd's collections of just about everything, stored in the barn and the various sheds.

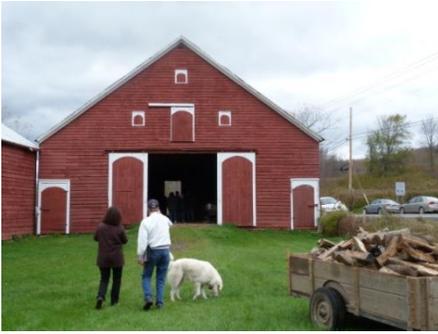
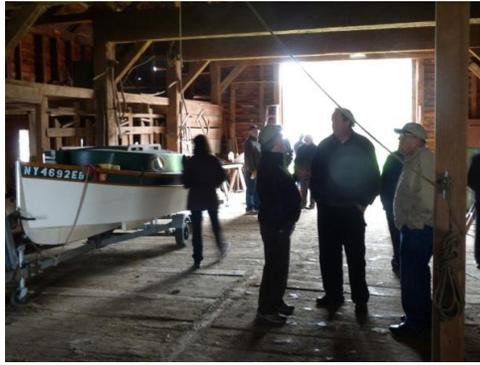
It is a 5 or 6 bay Dutch Barn- timber frame square rule barn; there are 4 regular bays and a double bay, plus an English barn added at the rear at a 90 degree angle. The original barn is about 40x60 feet, and each of the purlins is an unspliced 60 foot timber. It was built about 1820-1840. Below left, Pam & Ken.
