Hudson-Mohawk Vernacular Architecture

Burrowes Mansion, 94 Main Street, Matawan, NJ: Report of a Tour by HMVA Members on 16 August 2025

by Carla Cielo

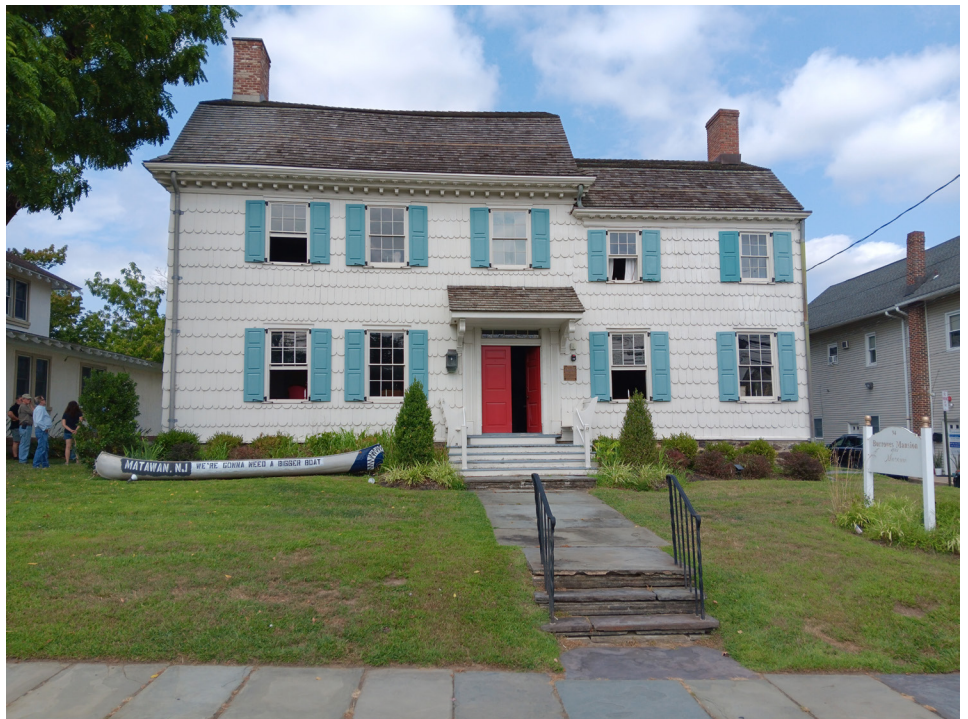
Historic house museums often boast an early construction date based on deeds or oral histories, but these dates often conflict with architectural evidence. The circa 1723 Burrowes Mansion in Matawan, NJ, however, may be an exception (Photo 1). The oldest remaining section of the house is a formal, first-period, Georgian farmhouse. Front and rear rooms (likely originally a kitchen and a parlor/chamber) and a side entry hall are located on the first floor of the earliest part of the house (Figure 1); four chambers, two having fireplaces, are located on the second floor (Figure 2) and there is a full basement and an attic. The house was constructed using an English box frame for the principal structure and is surmounted with a New World Dutch-framed gambrel roof. The principal front faces southeast. The property was owned by John Bowne III in 1723 and was sold to John Burrowes Sr. (1718-1785) in 1769. Burrowes was a wealthy grain merchant.

Photo 1. Front elevation of the Burrowes Mansion, August 2025 (W. R. Wheeler photograph).

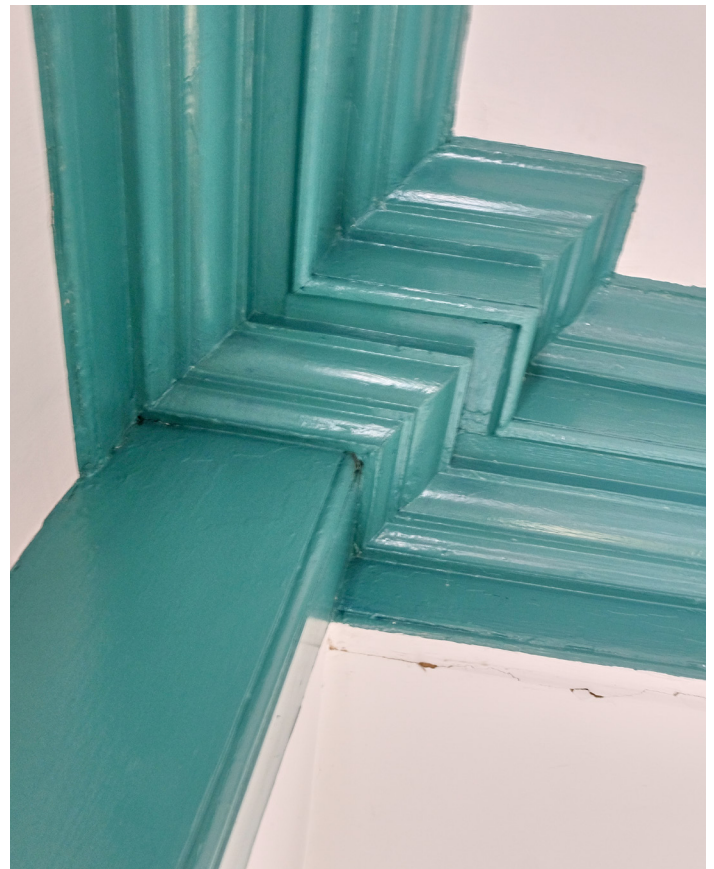
The first clue to the possible age of this house is the full-section corner posts which extend into the four corners of the front rooms and the rear corners of the back rooms (Photo 2). The posts are hidden behind beaded casing and a robust crown moulding. The corner

of one post at the rear first-floor room was chopped out to square the corner, but its full section remains visible at the crown moulding and in the second floor.

Photo 2. View of a full-section corner post and the crown moulding which wraps around the posts, 2025 (C. Cielo photograph).

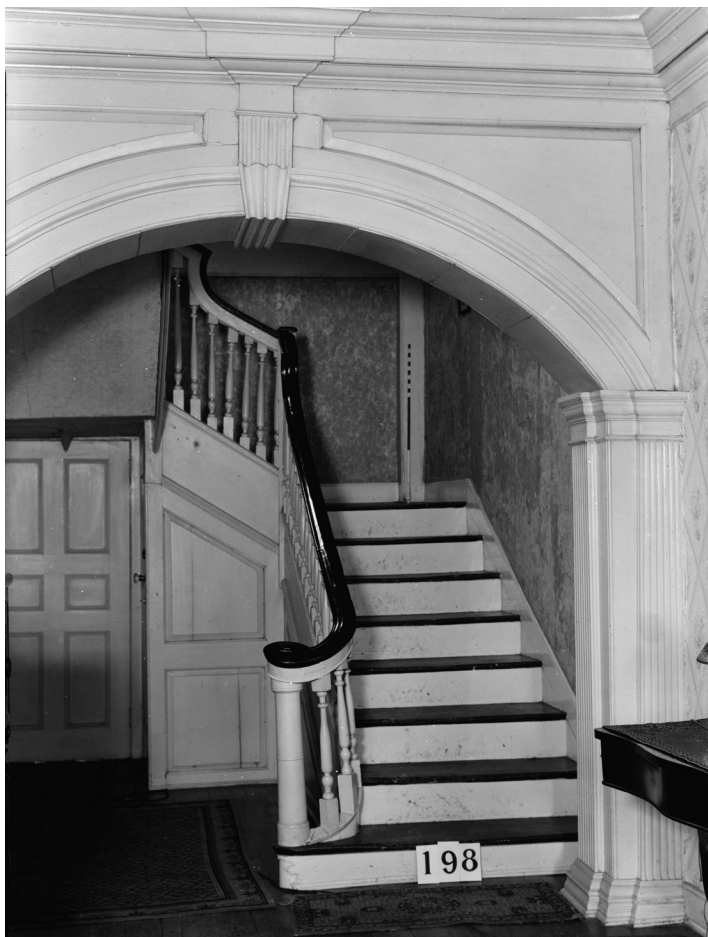
The wall between the front and rear rooms is structural and bears on a stone foundation in the basement. In the hallway, the framework is bridged by an archway

that is both structural and decorative (Photo 3). The archway is a common feature associated with the presence of a bearing interior wall in center or side hall houses built prior to circa 1760.

Photo 3. First floor side hall with archway (HABS NJ, 13-MAT, 1), 1936 (Nathaniel R. Ewan photograph).

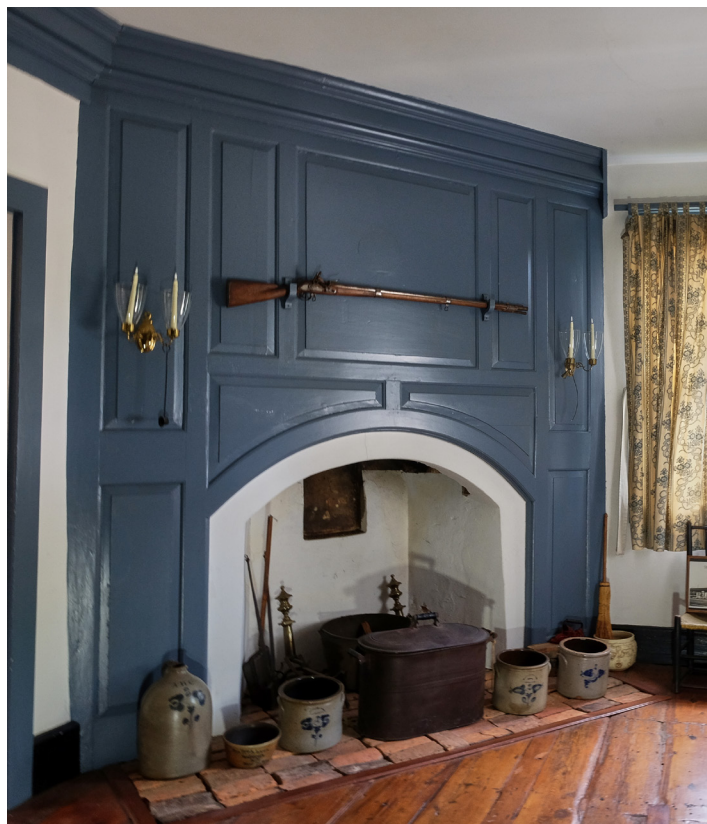
The house maintains a high percentage of original or early wall treatments including raised-paneled fireplace walls in the first-floor rear parlor (Photo 4) and in the two second-floor bedchambers (Photo 5). The fireplace surrounds do not incorporate mantels. The rear parlor and the rear chamber fireplace lintels are arched and the woodwork follows the arch (Photos 4 and 6).

Photo 4. First floor rear parlor, 2025 (C. Cielo photograph).

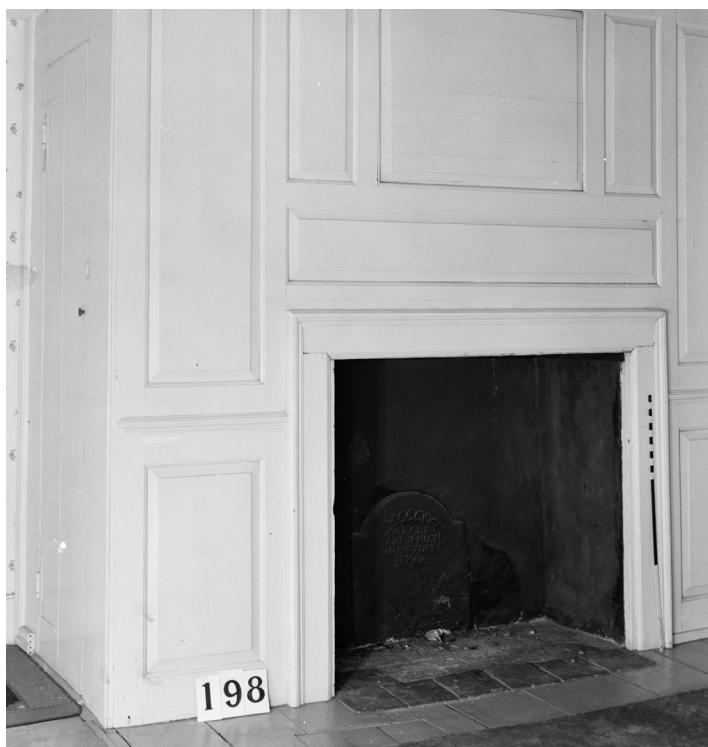
Photo 5. Second floor front chamber (HABS NJ, 13-MAT, 1), 1936 (Nathaniel R. Ewan photograph).

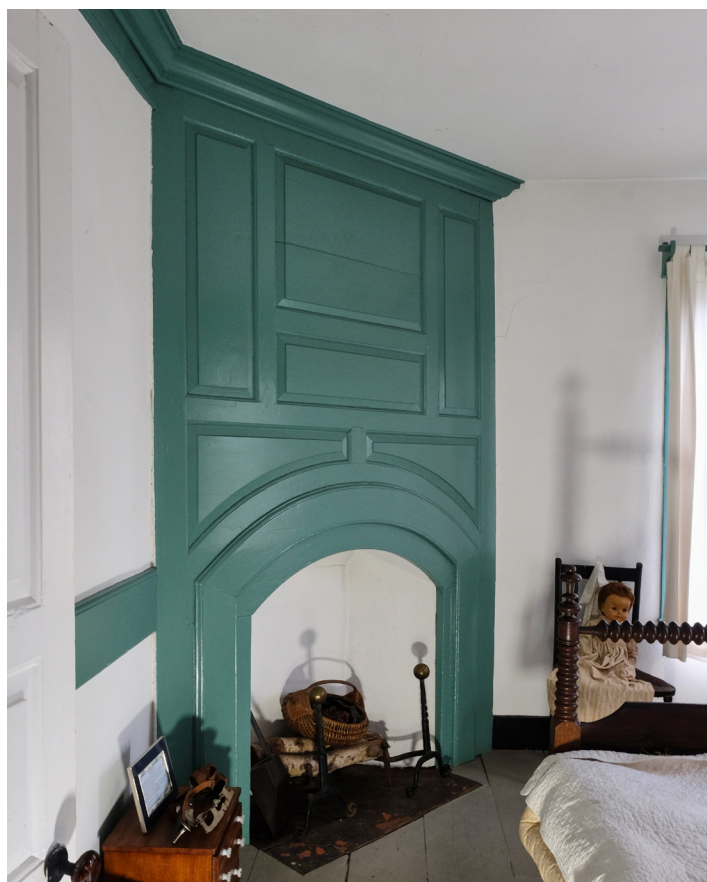
Photo 6. Second floor rear chamber, 2025 (C. Cielo photograph).

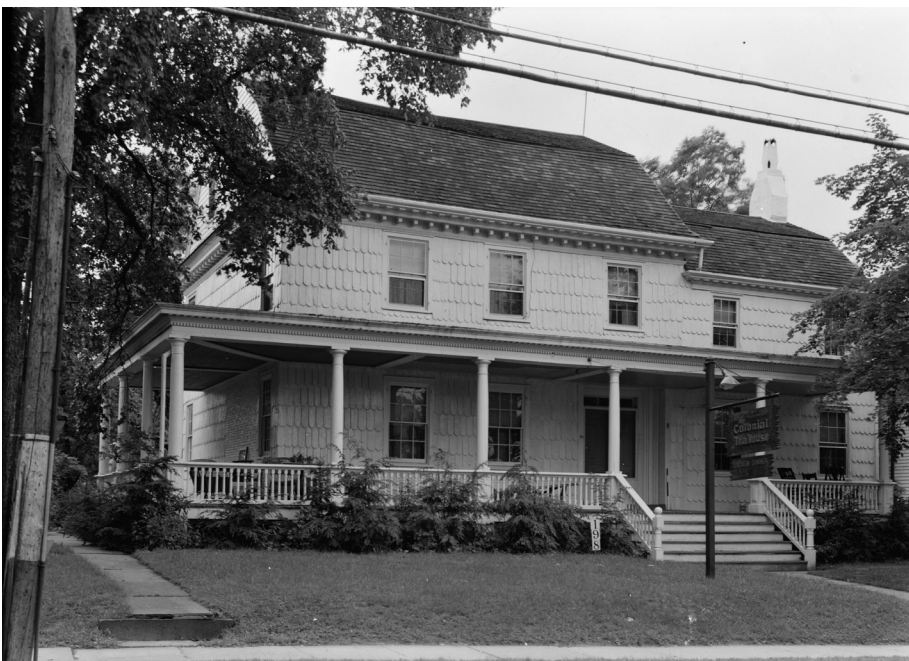
Photo 7. Front elevation (HABS NJ, 13-MAT, 1), 1936 (Nathaniel R. Ewan photograph).

Despite the high percentage of original or early features remaining in the house, significant changes have occurred. The first-floor front parlor has been altered in the Colonial Revival style. The alterations included the installation of a “Federal” style mantel that is said to have been taken from another house and which is flanked to the right by a restoration-period cupboard. This room likely originally had paneling like the other three rooms that were heated by fireplaces on the first floor, and perhaps was the kitchen until the rear addition was added in the early 20th-century to house a “modern” kitchen. This is suggested by the size of the chimney and hearth support as seen in the basement (Photo 9). The entryway has been conjecturally “restored” evidently after the removal of the full-width porch that was documented in the 1936 HABS photograph of the façade (Photo 7).

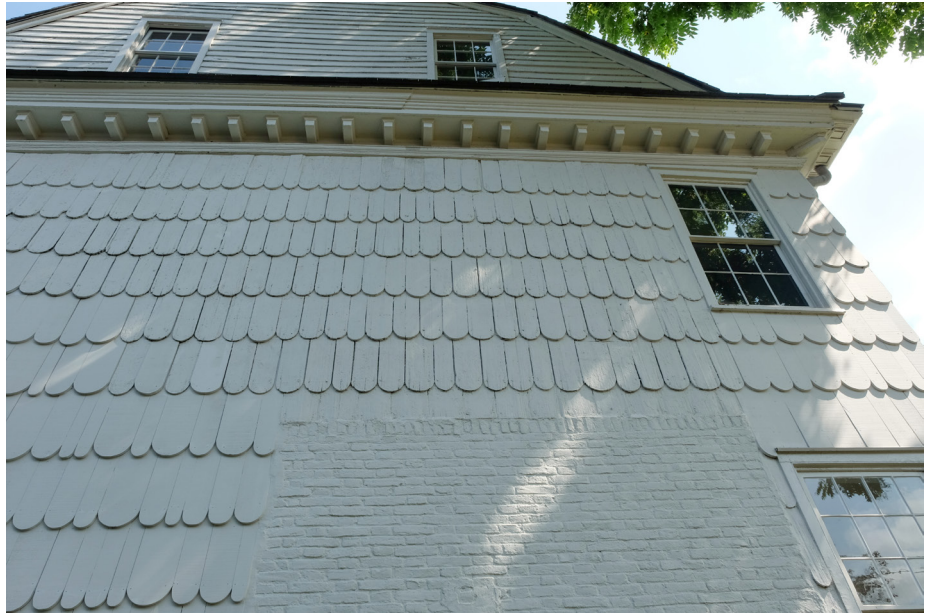
The house was evidently originally shingled on all four sides. The shingles are planed and have scalloped bottoms, and they are attached with wrought nails. Unfortunately, most have been replaced within the last eight years. A few original shingles remain on the southwest gable end wall above the brick fireback (Photo 8). The front and rear cornices continue along the side elevations of the oldest portion of the house; the gable end walls above this cornice are covered with clapboard siding. The northeast gable end wall is partially covered by a later addition; its upper portion is however visible within the attic of the addition. This former exterior wall retains clay-straw nogging with let-in horizontal laths to which the shingles were nailed below the cornice but no nogging or laths above the cornice. This suggests that this side was originally finished in the same manner as the southwest gable end, a fact confirmed by small areas of preserved shingles and clapboarding that remain on that end wall above the roof of the addition.

Photo 8. Original shingles, southwest gable end, 2025 (C. Cielo photograph).

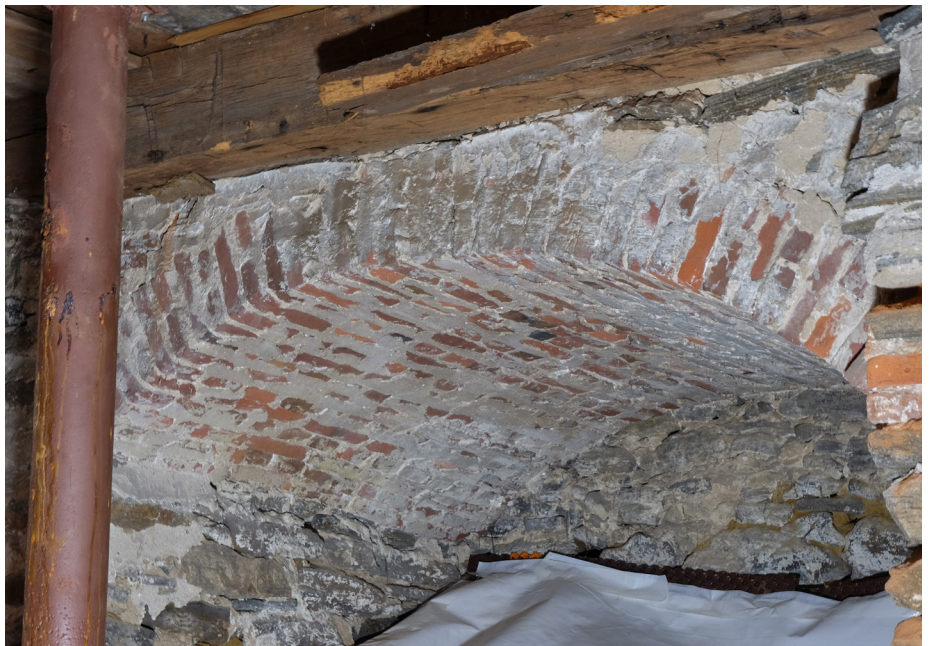
The bricks of the exposed fireback on the southwest gable end wall, which measures 9' wide x 10' high, and the bricks of the arched basement chimney supports for the first-floor fireplaces are both 1³/₄" high x 8¹/₂" wide x 3¹/₂" deep and indicate construction before the standardization of commercial bricks. The form of the chimney supports as seen in the basement is also interesting. Both are built with stone jambs that support a brick barrel arch (Photo 9). The barrel arch that supports the front room fireplace tilts upwards as it meets the face of the support. The

Photo 9. Chimney support under the front fireplace as seen in the basement, 2025 (C. Cielo photograph).

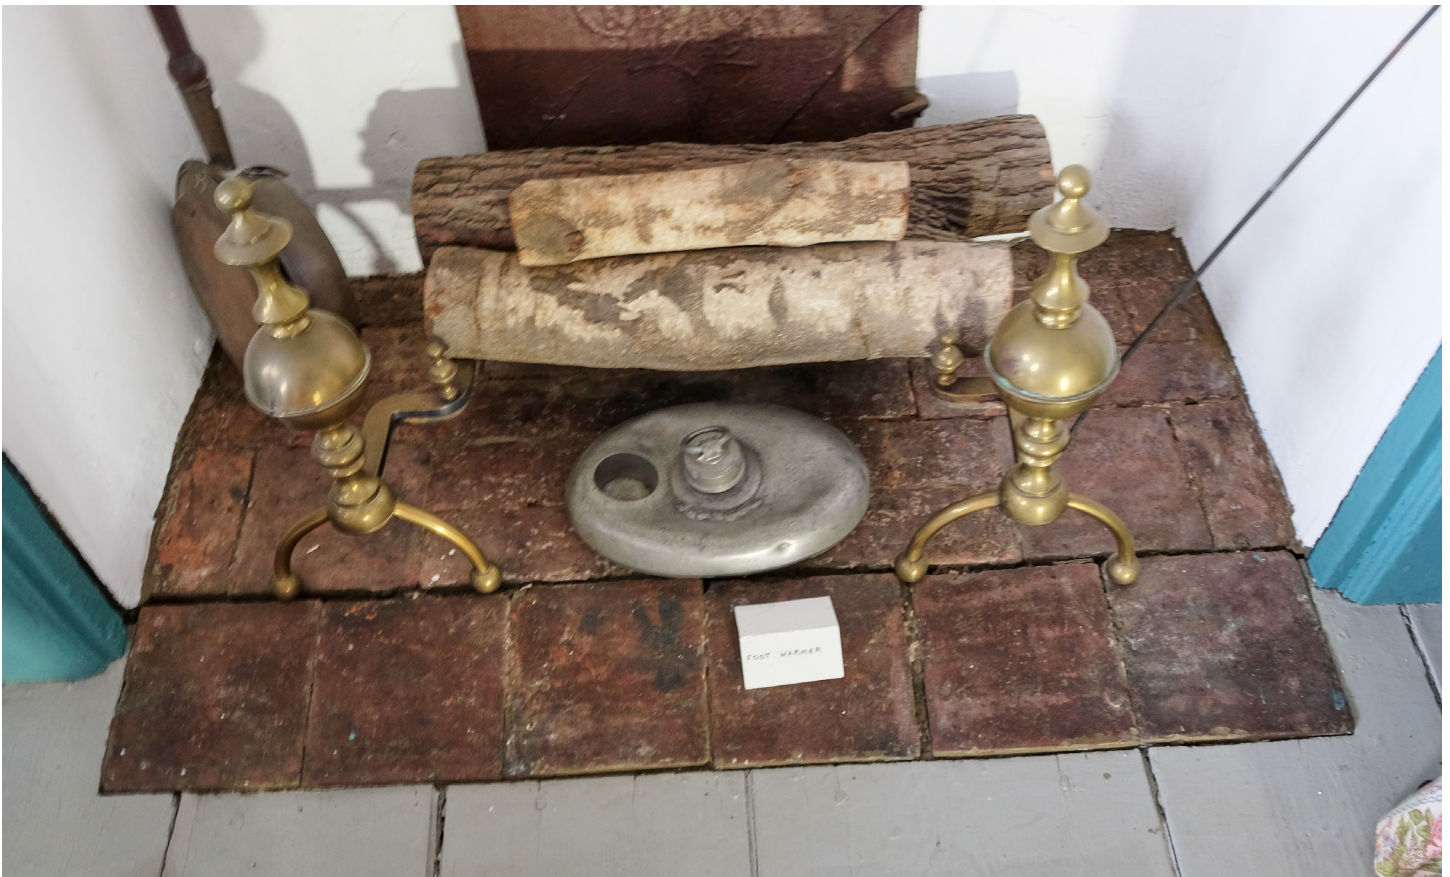
barrel arch that supports the corner fireplace of the rear room is oriented parallel to the gable end wall instead of diagonally like the fireplace above it. Double (square) bricks are used in the hearths (Photo 10).

Photo 10. Hearth of the second-floor front chamber fireplace, 2025 (C. Cielo photograph).

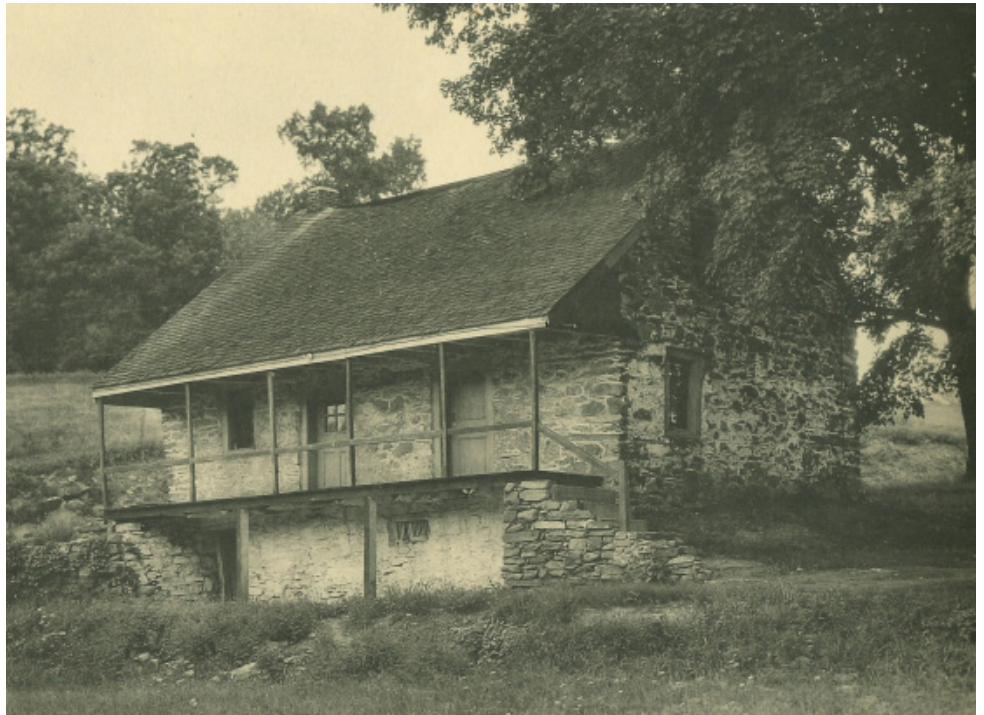
Figure 1. "Tietsoort" or Titsworth house, ca. 1932 (photo by Margaret De M. Brown).

irregular stone rubble, it is covered by a steep gable roof which extends in a long, straight slope to form an overhang beyond the front wall. As it is on a hill, a low basement story is exposed on the south front. The early plan was followed, the main floor consisting of two adjoining rooms each with its outside door. Notice the sparsity and small size of the windows, for better protection against the Indians. The east wall of the interior is panelled [sic].¹

It is a one and a half story house of rough slating stone rubble, with a steep gable roof and very small windows. As it stands on a hill slope, a basement story of white-washed stone is exposed on one side. In the interior at one end there is a panelled [sic] fireplace wall with a huge cupboard. Very wide floor boards, exposed beams, low ceilings, old hinges and doors, are authentic details. Although now used as a refreshment stand, the exterior has not been marred, north the interior very much altered. The house stands above Clove

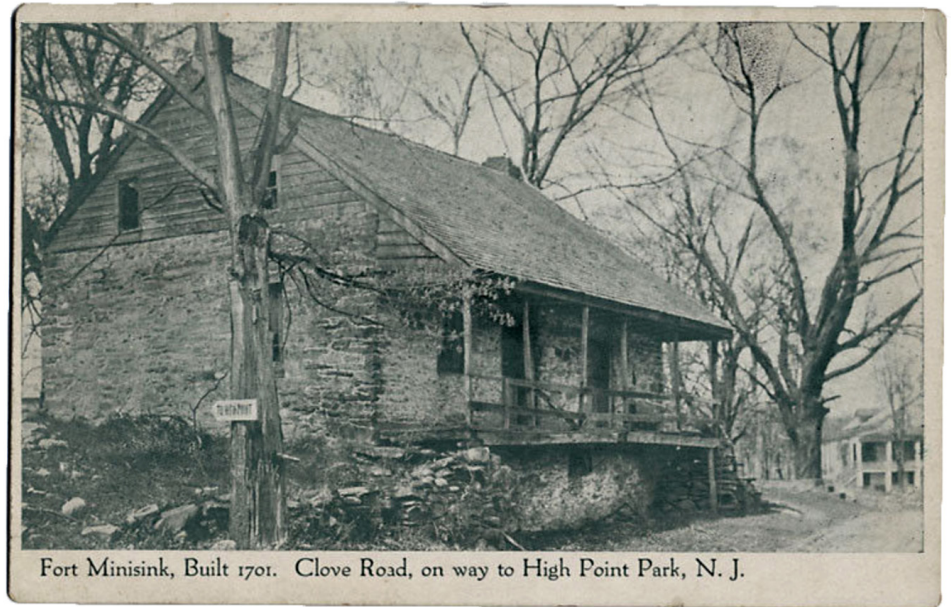
A ca. 1910 postcard view of the house by William H. Broadwell of Newark, NJ, shows it from another angle (Figure 2). The house does not appear to survive. If anyone can share more of its history, your editor will be obliged.

Figure 2. The house in a view ca. 1910 (photo by William H. Broadwell).
