Vol. 18, No. 7-9

Gable-fronted houses, a legacy from the Old-World Dutch

By John R. Stevens

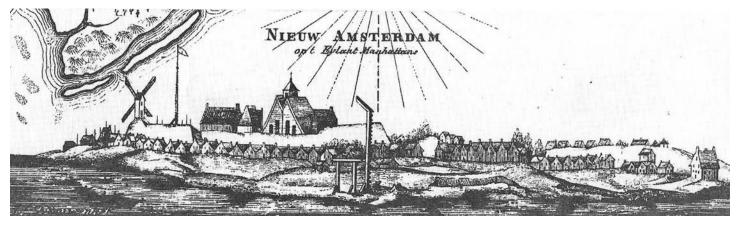
Fig. 1 – View of New Amsterdam, 1756. Lithographic copy of a view published in the second edition of Adrian Van der Donck's *Description of New Netherland* from D.T. Valentine's *Manual of the Common Council of New York* (1852).

The gable-fronted Dutch house is important because it is the type that best exemplifies the type of house brought by the Dutch to North America in the second quarter of the 17th century. It was primarily an urban style of building and can be seen in early views of New Amsterdam produced at that time, in particular the print published in Adrian Van der Donck's *Description of New Netherland* in 1656 (*Fig. 1*).¹

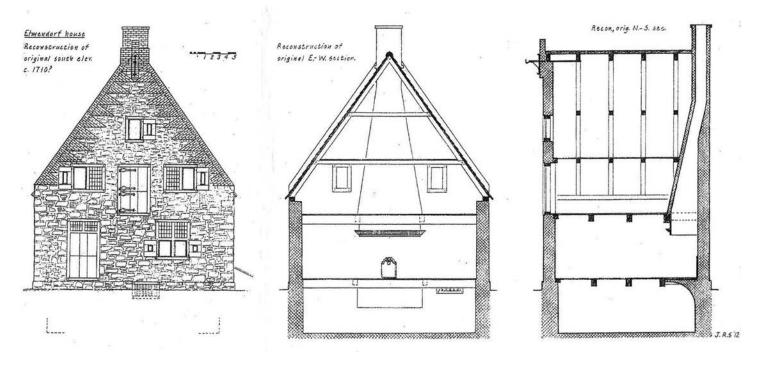
Drawing Set I - Elevation and sections of Ostrander-Elmendorf House. Drawings by author.

From the 18th century, we have the stone-walled Ostrander-Elmendorf House at Hurley, the oldest section of which was built c.1710 in gable-fronted form: a one-room house that measured 26 feet wide and 21 feet, 9 inches deep (Drawing Set I). These measurements are consistent with other one room houses that have been measured, whether built of timber or stone and gable-fronted or with side wall entrances. The beam structure and floorboards of the first and second floors of the original part of Ostrander-Elmendorf are original. The hearth of the original jambless fireplace that had been centered on the back wall was supported by a trimmer arch, which is exceptional in not being based on a corbel course protruding from the foundation wall. The only known parallel to this is in the Mattys Persen House in Kingston whose original walls survive from its having been burned by the British in 1777. The measurements of this house are almost identical to the Ostrander-Elmendorf House.⁴

The discovery of pantile fragments on the second floor of Ostrander-Elmendorf hinted at the possibility of the house once having had a pantile roof. Subsequently, more pantile fragments were found on the ground at some distance from the house and an archaeological dig in this area uncovered many pantile fragments, some quite large. Incidentally, pantile fragments were also found by the same archaeologist, Joseph Diamond, in excavations at the Mattys Persen House in Kingston. If a house had a pantile roof, it would seem a given that it would have had gable parapets. Only one example of a stone house with brick gable parapets made with vlechtingen or "mouse-toothing" had been known to exist: Fort Frey at Palatine Bridge on the Mohawk River.⁵ But in 2007 it was discovered that the oldest stone section of the Cornelius Cool House in Hurley had gable parapets with brick vlechtingen, which later had been cut back below the roof line.⁶ Finding this precedent made it highly likely that Ostrander-Elmendorf also had this construction feature.

The reconstruction of the Ostrander-Elmendorf House presents a house clearly displaying its Old World Dutch antecedents, as also do the brick-fronted, timber-framed Abraham Yates house of c.1725 in Schenectady and the brick fronted stone Teunis Slingerland House of 1762 at Feura Bush in Albany County.⁷

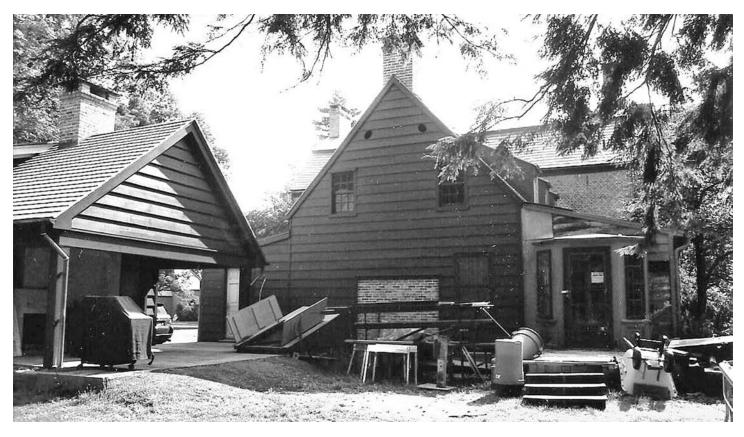
Fig. 2 – View of the Dirck Wesselse Ten Broeck House, ca. 1705, Clermont, Columbia County, attached to rear of the brick Ten Broeck Bouwery erected in 1762. Photo by author.

Now a rear ell attached to the Ten Broeck Bouwerie in Clermont, the timber-frame dwelling was dendrodated at ca. 1705. It was built by Dirck Wesselse ten Broeck (1638-1717) on the banks of the Roeloff Jansen's Kill, but because of the threat of flooding, it was moved to higher ground. At this point an addition-

al room was added covering the original front-gable façade. The second-floor end beam has the disused mortices from a transomed doorway and a cross-window that had been part of the original facade. In 1762 it became the service wing to a grand two-story brick mansion with a gambrel roof, known as The Bouwerie, built by a later Dirck Wesselse ten Broeck (*Fig. 2*). In recent years the Bouwerie property was purchased by Dianne O'Neal who has employed HVVA member Conrad Fingado to do an extensive renovation to the building. Conrad's work has exposed the evidence of the earlier house.

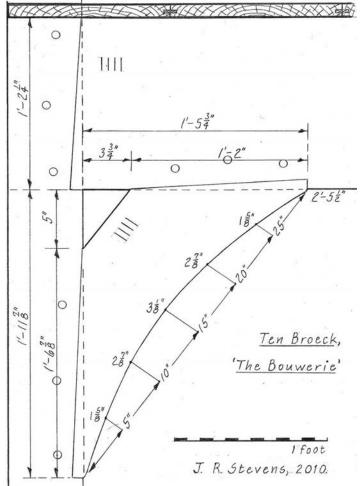
Fig. 3 – Measured drawing of corner brace in Ten Broeck House by author.

The original structure was a gable-fronted, with one room. It was 21 feet, 2 inches wide by 18 feet, 10 inches deep (*Drawing Set II*). It consisted of five framing bents, the beams of the three interior bents having braces (korbeels) of an early form with open corners (*Fig. 3*). The height from the first floor to the underside of the second floor boards is 8 feet, 5 $\frac{1}{2}$ inches. As previously noted, the front wall had a doorway with a mullioned transom and a cross window. There is evidence that the second floor end beam originally projected to create an overhang, like that on the Pieter Winne House at Bethlehem, Albany County. The house was 1½ story with knee walls and had a steeply-pitched roof with two tiers of collar ties. While the pitch of the roof was reduced somewhat when the 1762 mansion was built, the original rafters were re-used. It was possible to ascertain the original roof pitch from the redundant collar tie mortices as having been 55 degrees. Centered on the back wall there had been a jambless fireplace about 7 feet, 6 inches wide. The framing bents have "marriage marks" from the façade end to the fireplace end.

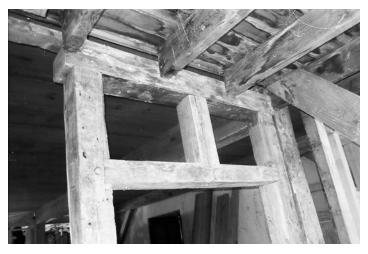
Fig. 4 - View of extant door frame in Ten Broeck House. Photo by author.

doorway with a mullioned transom set right against the corner post of the original structure (Fig. 4). The craftsmanship of the addition is noticeably inferior to the original work. The posts of the south wall, original and new, were given marriage marks on their exterior faces about 21 inches above the sill level numbering them from east to west. The exterior walls are infilled with brick (nogging) which was plastered on the interior, but leaving the faces of the wall posts exposed about ³/₄ of an inch. There is clear evidence of there having been a cross-window on each side wall between the second and third posts from the fireplace end. The exterior was weather-boarded. There is a basement under only the original part of the house which suggests the addition was built some time after the move. At an unknowable date, the jambless fireplace was rebuilt with jambs. At the time of construction of the 1762 mansion the roof pitch was reduced to 47 degrees so that its ridge came below the top of the lower slope of the gambrel roof.

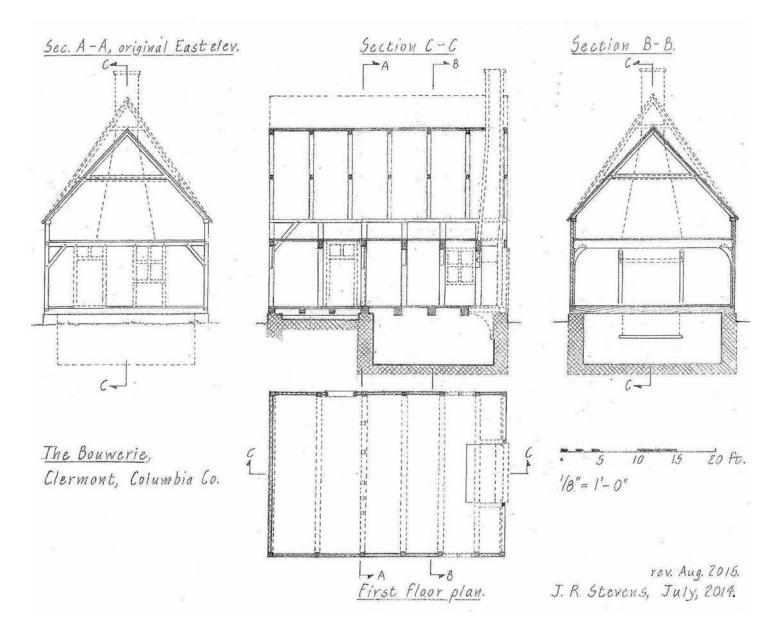
$\ensuremath{\text{Drawing Set II}}$ – Plan and sections of the ca. 1705 Ten Broeck House. Drawings by author.

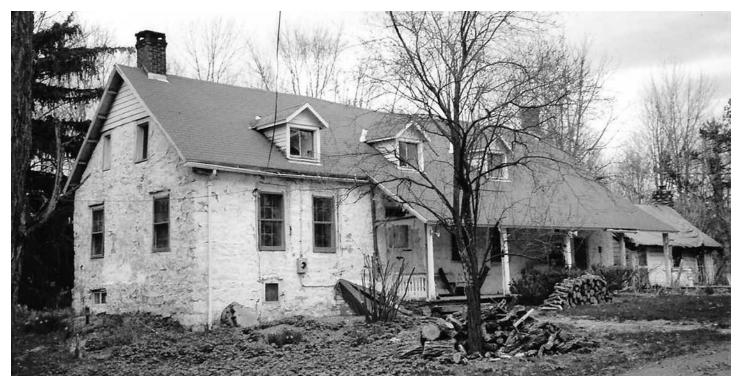
Fig. 5 - View of Cantine House from south, construction dates unknown. Photo by author, 2007.

The whitewashed stone house on Jacobsen Lane south of Stone Ridge is believed to have been built by a member of the Cantine family, although a detailed documentation of the building has yet to be done (*Figs. 5 & 6*). It is illustrated on page 179 of Eberlein and Hubbard's Historic Houses of the Hudson Valley (1942) simply as "Long Whitewashed House, Stone Ridge".

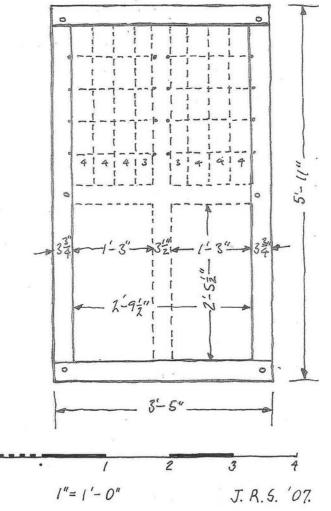
Cantine house, Window frame, south wall.

Fig. 7 – Measured drawing of window frame, south wall, Cantine House by author.

to it as would be the normal circumstance. This evidenced that the house, like the original section of the Ostrander-Elmendorf House, originally had a gable-fronted configuration. One of the front window frames of this part of the house appeared to have been converted from a cross-window frame by the removal of the mullion and transom (*Fig. 7*). This section of the house measures 25 feet in width, and 21 feet, 6 inches in depth, very similar to the Ostrander-Elmendorf House.

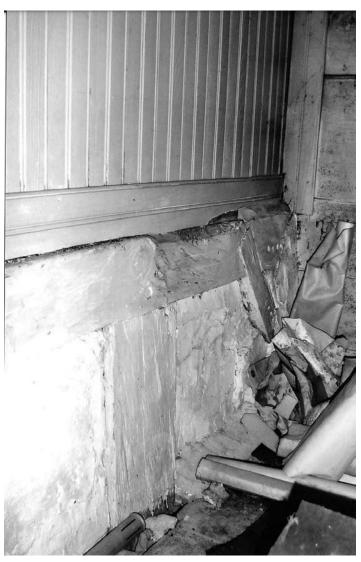
Fig. 8 – View of wall framing, Cantine House. Photo by Maggie MacDowell, 2006.

surprisingly, that the side walls of the center section were of timber frame construction (*Fig. 8*). The house was purchased by an English woman who the author has approached her several times for permission to document the interior, but such permission has not been granted.

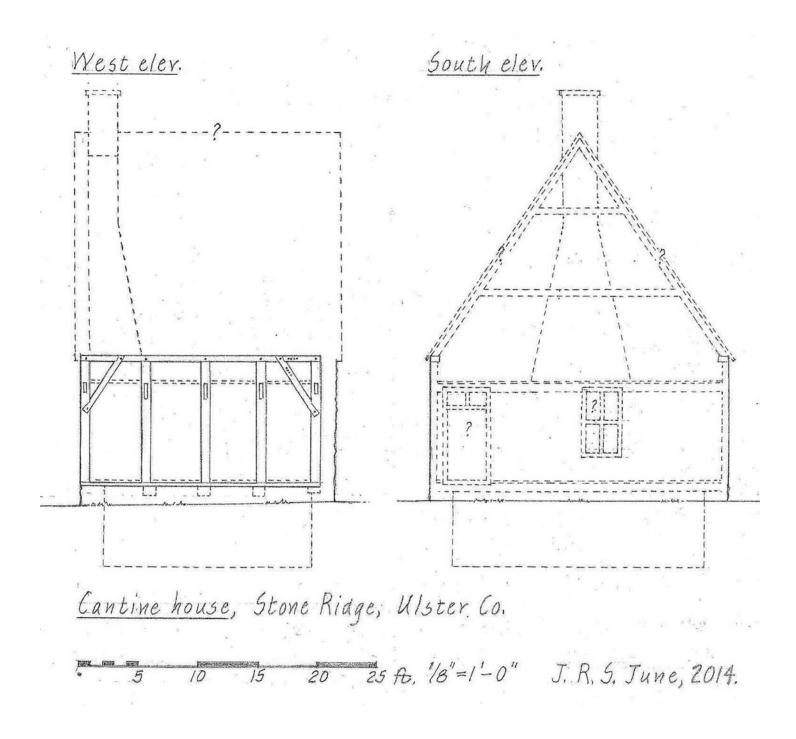
The original unit of the house would seem to have been a "stone-ender" with the stone end wall extending across the south corner posts. The north end (fireplace wall) has stone infill between the corner posts and above and below the end wall second floor beam. The drawings included here show the main features of the original form of the house, and have to be regarded as tentative until such time as the house can be thoroughly studied and accurate drawings can be made of it (*Drawing Set III*).

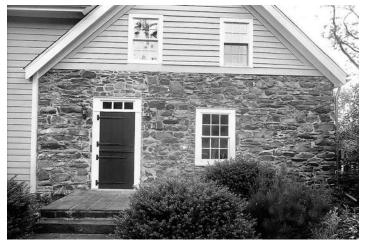
Fig. 9 – View of Du Puy House from east. Photo by author.

This house is something of a discovery. It is not in any book the author is aware of. It is located on the west side of Van Wagenen Lane which starts at Hurley Mountain Road near its south end, just past the bridge over the Esopus Creek (*Figs. 9 & 10*). It faces approximately east. In the central part of the façade are four inscription stones, one of which displays the date 1722. Other stones are carved with initials that suggest the house was built for a Du Puy. The datestone which is centered on the end wall of the addition shows AKS ND and 1733 (*Fig. 11*).

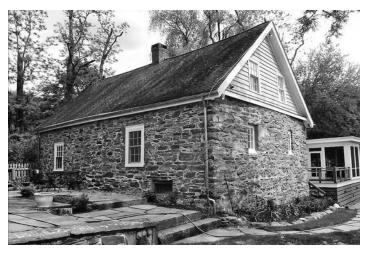
Fig. 10 - View of Du Puy House from northwest. Photo by author.

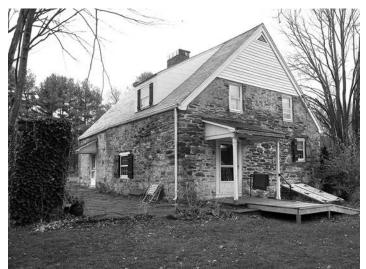
Fig. 13 – View of Vernooy-Bevier House, 2014. from southeast. Photo by Neil Larson, 2015.

The Vernooy-Bevier house is located at the end of a lane off the east side of route 209, a short distance north of the Village of Ellenville (Fig. 13). There is a brief description of it on page 233 in Helen Wilkinson Reynolds' Dutch Houses of the Hudson Valley Before 1776 (1929), and is illustrated there by a photograph taken in 1906 identified as "The small house near Wawarsing" (Fig. 14). This house was first visited and photographed by the author on September 18, 1994 in field trip with Peter Sinclair prior to the founding of the HVVA. I saw it again on August 19, 2006 with a sizeable contingent of HVVA members. The elderly lady living in the house would only allow Jim Decker to see the interior; I took the opportunity to measure the exterior of the house.8 Eight years later I was able to get interior measurements.

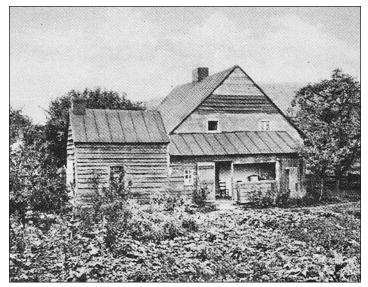
Fig. 14 – View of Vernooy-Bevier House, 1906. From Helen Wilkinson Reynolds, Dutch Houses in the Hudson Valley Before 1776 (1929), 101.

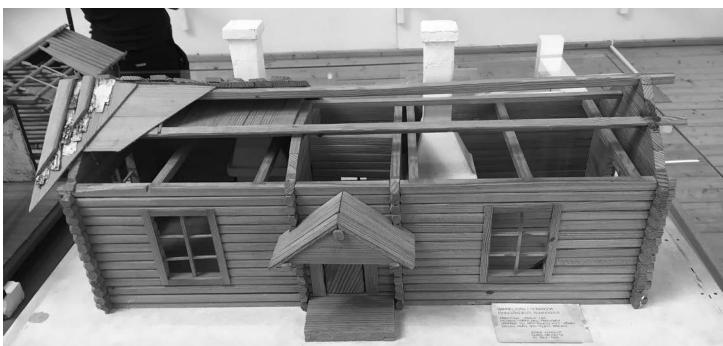
Fig. 4 – Detail of log wall and plank roof construction, Skansa Museum. Photo by Neil Larson, 2015.

Virtually all the historic buildings were built of logs: houses, barns, granaries, as well as churches and schools (*Fig. 4*). In many cases, the logs were covered with vertical boards and battens. The wood roofs were particularly interesting (*Fig. 4*). Birch bark was laid underneath the planks for waterproofing with the edges left exposed at the eave. Sometimes the edge of the bark was cut in a saw-tooth for added decoration. Another novel feature at Skansa and elsewhere was the unusual angled pole fencing (*Fig. 5*).

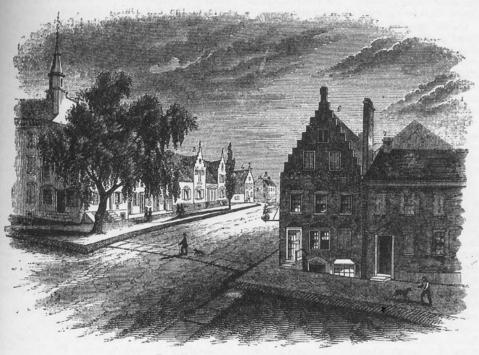
V.-NORTH PEARL AND STATE STREETS.

No. V exhibits the corners of North Pearl and State Streets, looking up Pearl. The most conspicuous objects are the ancient building known as the Lydius House (6), with its terraced gable, and the adjoining mansion (7) of William Pitt Beers. The corner house was built expressly for a parsonage, to accommodate the Reverend Gideon Schaets, who arrived in Albany in 1652, and became the pastor of the Reformed Dutch Church. The materials for the building were all imported from Holland — bricks, tiles, iron, and wood-work. They came over with the church bell and pulpit in 1657. When I was quite a lad I visited the house with my mother, who was acquainted with the father of Balthazar Lydius, the last proprietor of the mansion. To my eyes it appeared like a palace, and I thought the pewter plates in a corner cupboard were solid silver, they glittered so. The partitions were made of mahogany, and the exposed beams were ornamented with carvings in high relief, representing the vine and fruit of the grape. To show the relief more perfectly, the beams were painted white. Balthazar was an eccentric old bachelor, and was the terror of all the boys. He was fond of his pipe and bottle, and gloried in celibacy until his life was in "the sere and yellow leaf" Then he gave a pint of gin for a squaw, and calling her his wife, he lived with her as such until his death, in 1815. His fine old mansion was demolished in 1832, when it was believed to be the oldest brick building in the United States.
